Longwood Condominium

11811 Avenue of the PGA, Palm Beach Gardens, FL, 33418

Structural Integrity Reserve Study

For period beginning January 1, 2025

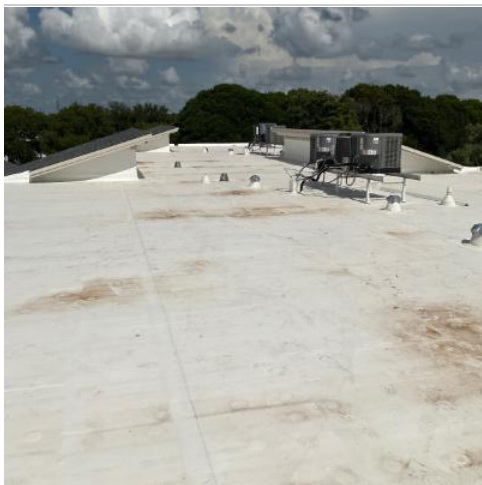
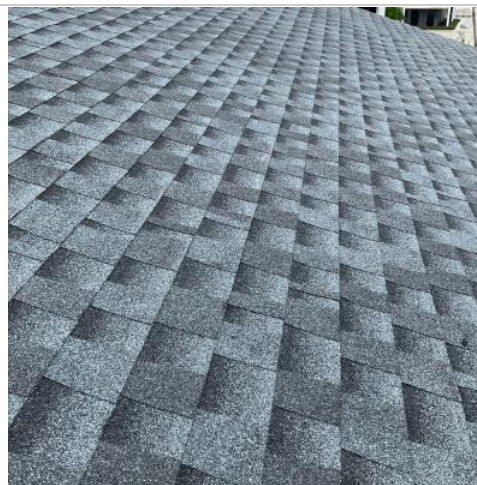
1A - Roof System

The roofs comprise a combination of low-slope Thermoplastic Polyolefin (TPO) membrane installed over the wooden roof deck and asphalt shingles over pitched mansards.

Flashing is used around roof penetrations and edges to ensure waterproofing. The system requires periodic inspection and maintenance to ensure its durability and longevity.

Per building records, the roofs were replaced in phases between 2018 and 2024.

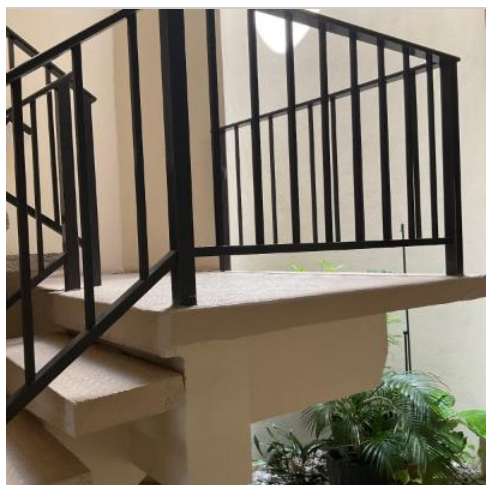
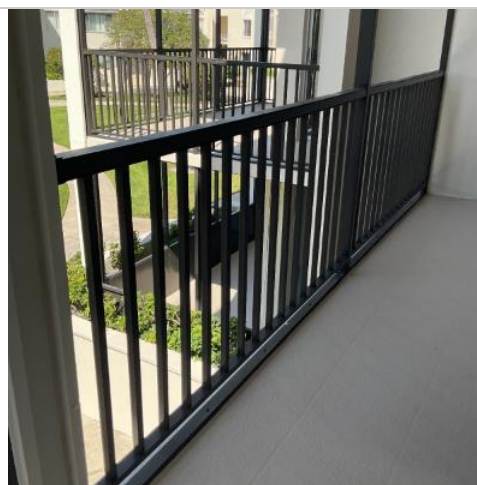
2A - Balcony and Stairwell Railings

Aluminum railings at balconies, catwalks, and staircases were observed to generally be in good to fair condition, consistent with the building's age.

Periodically inspect post attachments and hardware for corrosion, rust, and waterproofing concerns. Regular inspections should be conducted as part of routine maintenance to ensure safety and stability, and prompt repairs should be carried out as necessary.

Railing restoration, including painting and repair maintenance, should be performed with the building painting project on a 8-year cycle.

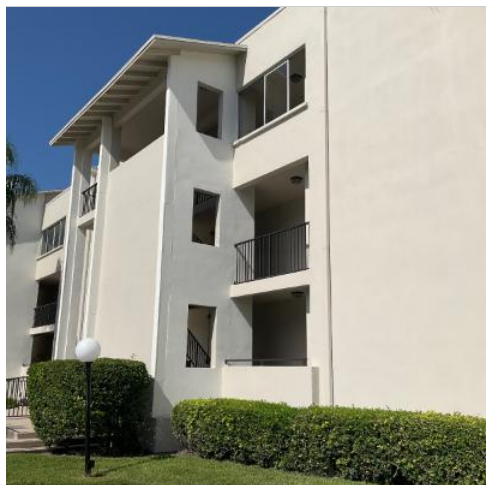
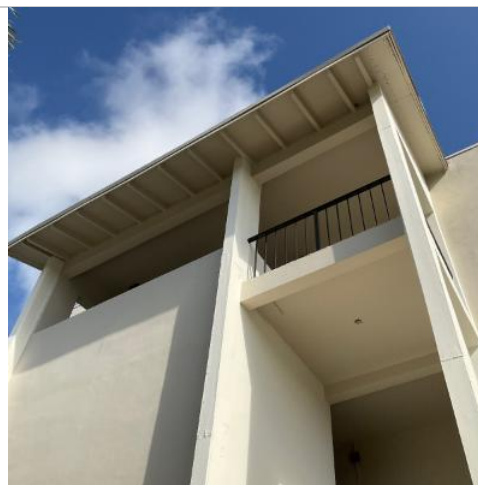
2B - Balcony and Building Concrete Restoration

The concrete framing is generally in good condition and appears consistent with its age. All seven buildings have recently had recent concrete and stucco restoration performed.

Based on the drawings, the floor systems consist of elevated concrete slabs with mild steel reinforcement and prestressed concrete beams.

Concrete restoration and maintenance should be performed with the building painting project on a 8-year cycle.

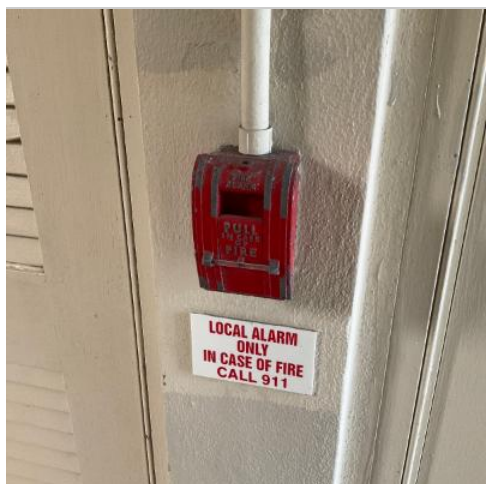
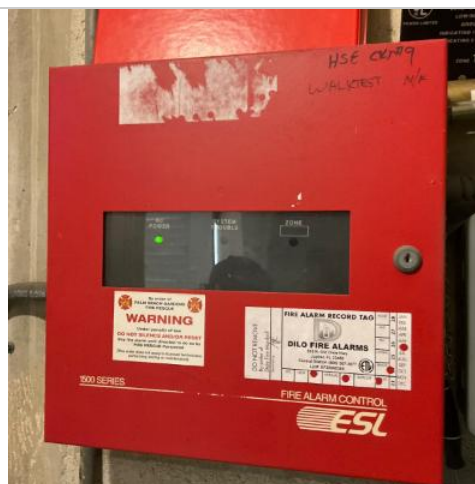
3A - Fire Alarm System

The cost is a future allowance to upgrade the fire alarm system, which includes smoke detectors in common areas and pull stations at exits.

The buildings' fire alarm panels are located in its main electrical room.

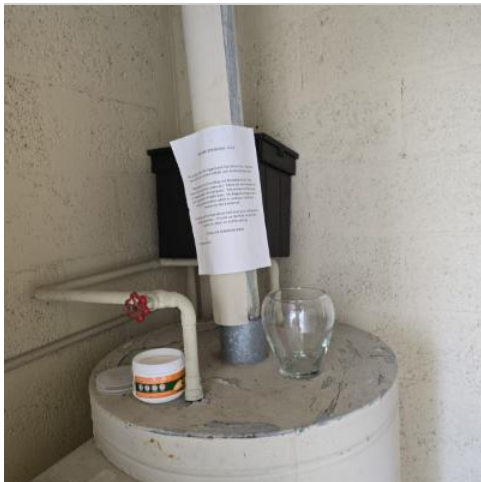
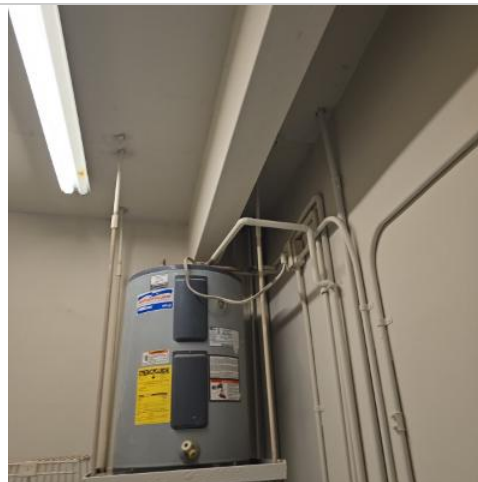
4A - Plumbing System

The domestic water system comprises a network of pipes and rises that distribute potable water through the buildings to the individual units.

Sanitary pipes remove wastewater from the units and distribute it to the drainage system.

Repair consists of 20-year deferred maintenance for pipe fittings and potable water distribution equipment.

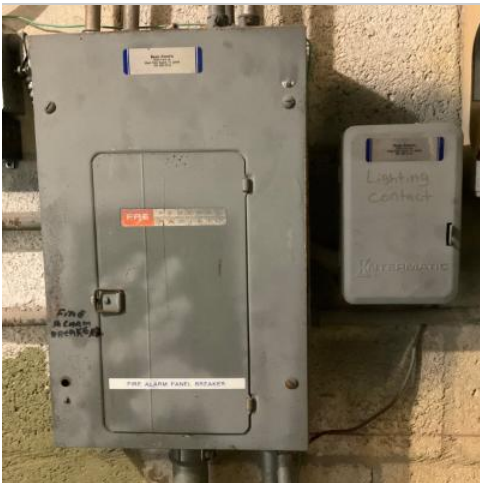
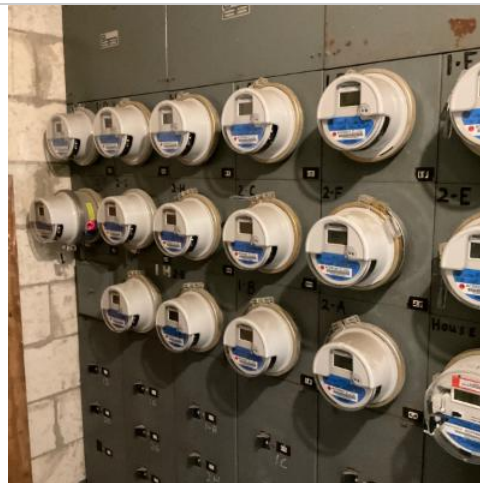
5A - Electrical Distribution System

The buildings' electrical distribution system comprises a network of conduit and wiring, circuit breakers, utility meter banks, and house panels designed to provide power to all units and the common areas.

Several buildings contain distribution equipment manufactured by Federal Pacific Electric (FPE). FPE equipment is obsolete, associated with higher failure rates, and may not be covered by certain insurance carriers.

Repair consists of 20-year deferred maintenance to replace and upgrade electrical distribution equipment.

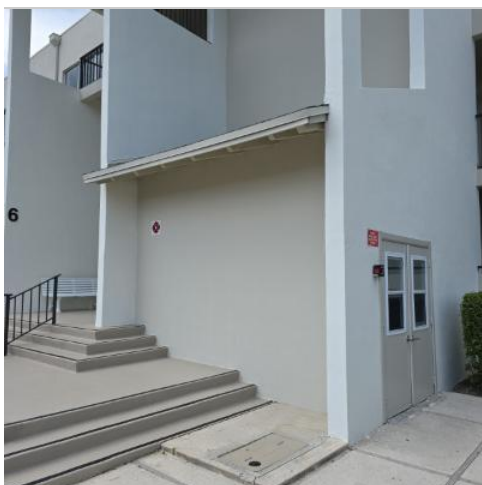
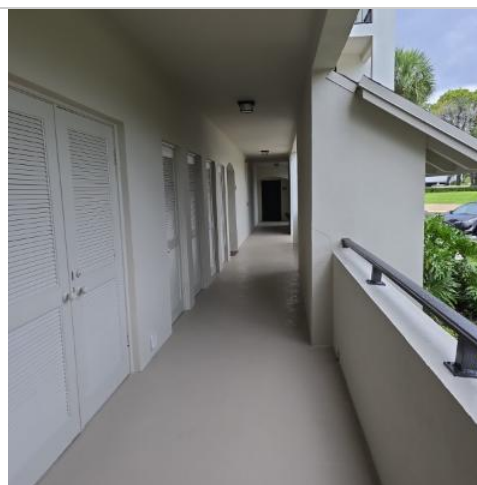
6A - Waterproofing and Exterior Painting

Coatings are in good condition following a recent painting project.

Whenever feasible, deck re-coating should coincide with building exterior painting or other exterior waterproofing projects. Concrete decks must be waterproofed to prevent deterioration, spalling, and related issues.

Regular inspections, at least annually, are recommended to identify any maintenance or repair needs. If water does not drain effectively from the decks, additional sloping may be necessary to prevent ponding water and accelerate deterioration.

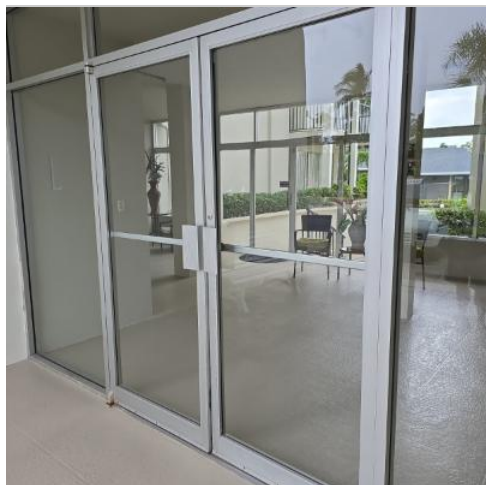
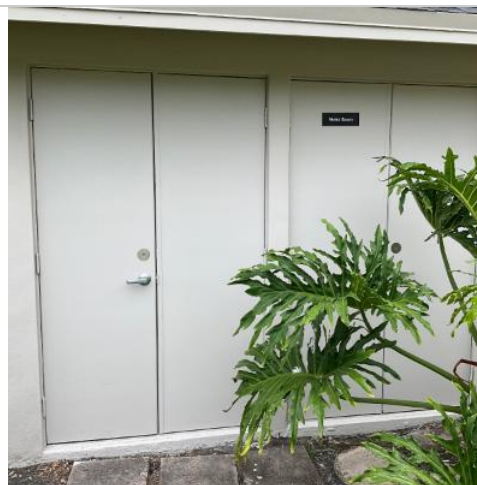
7A - Exterior Doors

Exterior doors are in fair condition with signs of corrosion.

Conduct periodic inspections and repairs as needed to maintain the appearance, security, and functionality. Painting should be coordinated with building exteriors or other painting and waterproofing projects to preserve the appearance and extend the useful life. Utility doors generally have a long lifespan, but occasional replacements may be necessary, particularly for doors in more exposed locations.

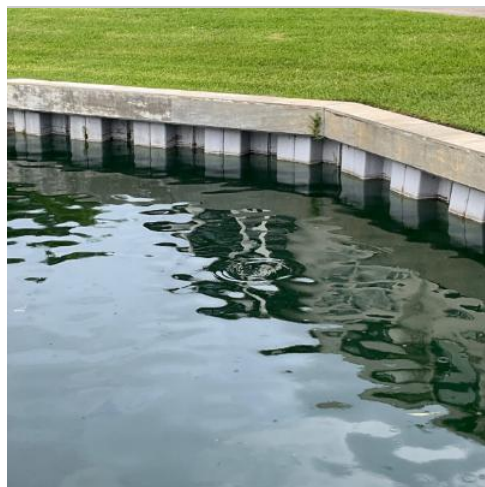
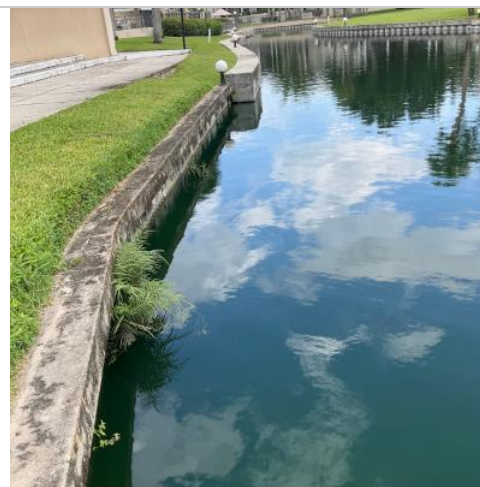
9A - Seawalls

The property includes an inland lake protected by a concrete seawall. Several sections have been replaced recently, while three original sections, approximately 413 linear feet long, remain.

Typical repairs needed for the seawall include sealing cracks in the older sections to prevent water seepage, reinforcing the cap to maintain stability, and adjusting anchors to correct slight leaning in some areas. Additionally, minor erosion behind the wall requires backfilling with gravel and installing a proper drainage system to manage water pressure. With proper maintenance, the expected lifespan of the seawall is approximately 30-50 years, depending on environmental conditions and upkeep.
