MILESTONE INSPECTION REPORT FORMS - STRUCTURAL BSIP INSPECTION FORM

MILESTONE INSPECTION REPORT FORM PHASE 1

a. Name on Title: THE LONGWOOD CONDOMINIUM ASSOCIATION, INC.			
b. Street Address: 11811 Avenue of the PGA, Palm Beach Gardens, FL 33418

LONGWOOD CONDO - BLDG 4 - REPRESENTATIVE PHOTOS

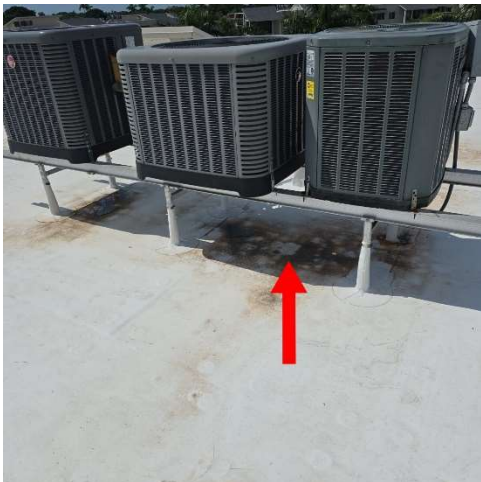
- Standing water or membrane staining.
- Some exposed nail heads along the asphalt shingle areas.
- Poorly installed or sealed flashing details, especially along TPO to asphalt transitions.

PHOTO-09 Typical Roof Staining

- Repair areas with truss and fascia rot.
- Clean and maintain the roof system, drains, scuppers, and downspouts per the manufacturer's warranty and as part of the routine maintenance program. Ensure all downspouts are equipped with splash blocks and drain away from the foundation to prevent erosion. Install any missing roof drain domes.

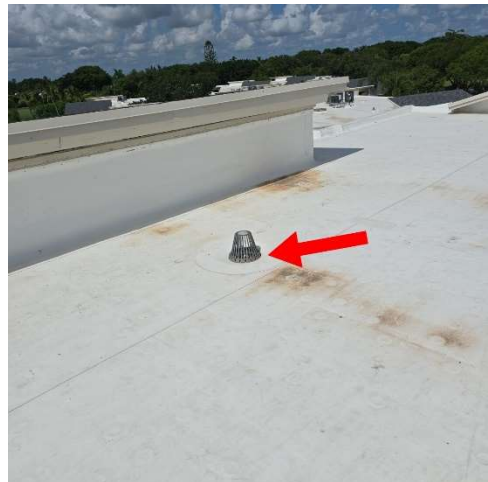
1. Internal roof drains, perimeter scuppers, and downspouts are generally in good condition.
2. Roof, drain, scupper, and downspout cleaning is required as part of regular maintenance.
3. Maintain splash blocks and downspout extensions to prevent erosion.

PHOTO-10 Typical Roof Drain

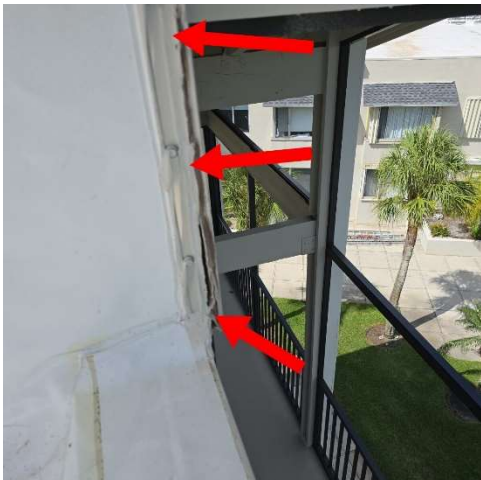
- Isolated locations of wood rot along the fascia or overhang truss ends.
- Corrosion noted at select column bases/brackets.
- Areas of cracked, damaged, or unsound stucco finishes.
- Areas of damaged or deteriorated exterior sealants.

PHOTO-11 Typical Deteriorated Sealants

- Repair any damaged or deteriorated sealants per the manufacturer's installation instructions (i.e. surface prep, cure time, and application thickness). Repair any adjacent areas of wood rot, moisture intrusion, efflorescence, and corrosion as necessary.

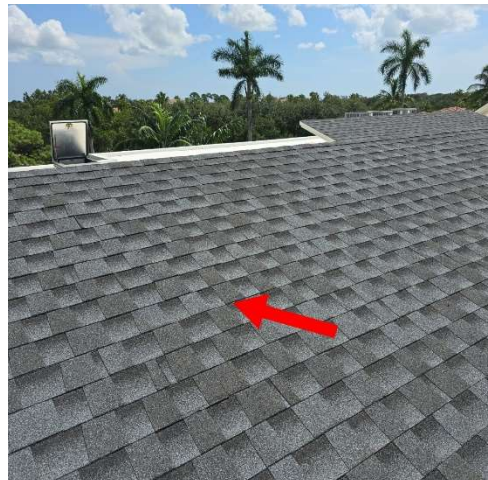
PHOTO-12 Exposed Roof Nail

- Quantify and repair areas of unsound, cracked, or damaged stucco around the building exterior.
- Repair any exposed asphalt shingle nail heads and poorly installed or sealed roof flashing.

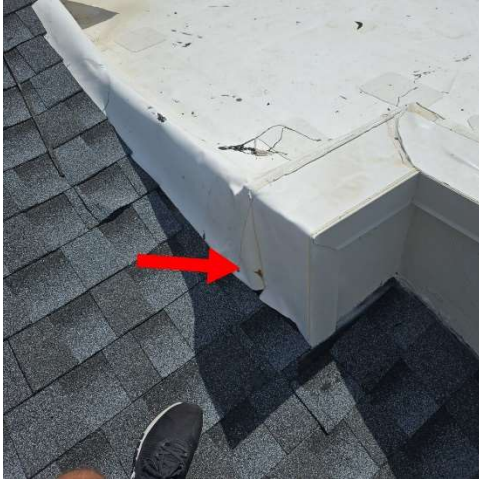
PHOTO-13 Exposed Roof Nail

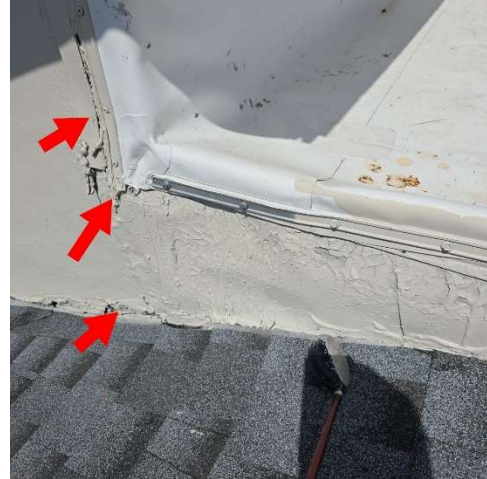
PHOTO-14 Typical Poor Roof Flashing

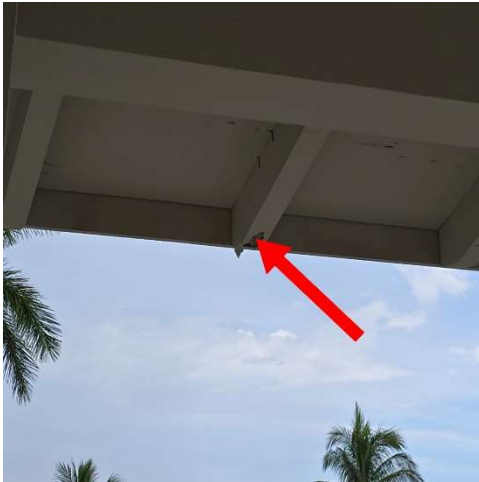
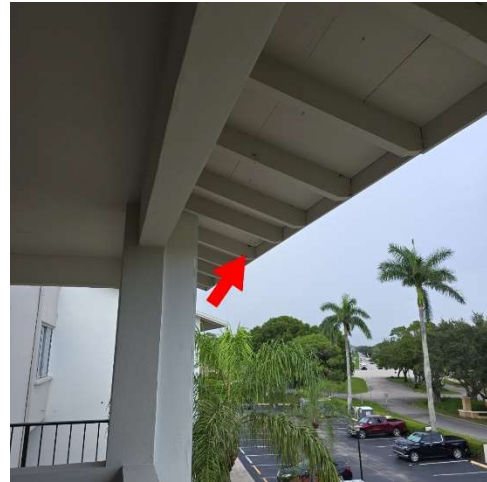
Isolated areas of wood truss end or fascia rot along overhangs.

PHOTO-15 Typical Truss Fascia Rot

PHOTO-16 Typical Truss Fascia Rot

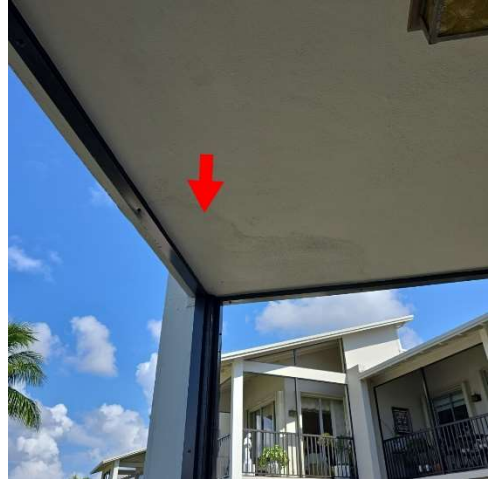
Per building records, the building recently performed a concrete restoration project circa 2024 (BCOM-23-08-00676)

PHOTO-26 Typical Previous Concrete Repair

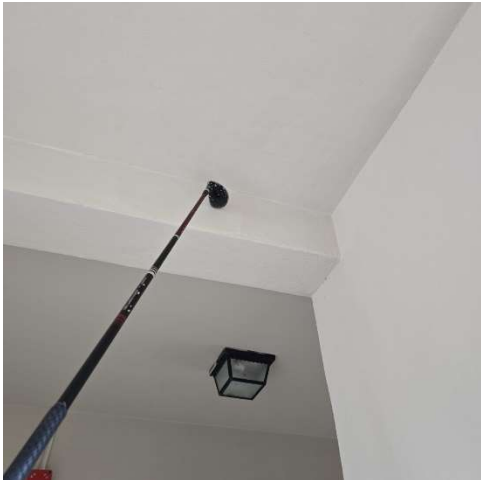
PHOTO-27 Typical Unsound Stucco

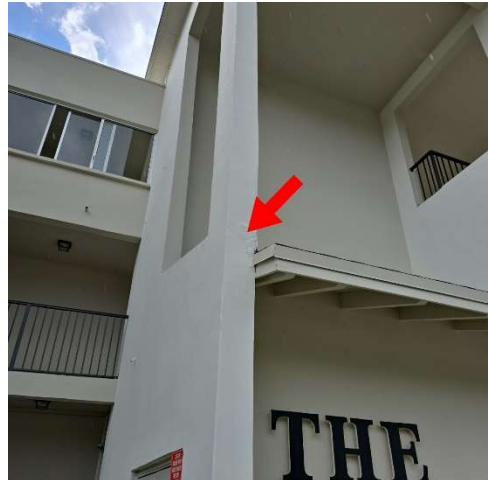
PHOTO-28 Damaged Stucco Front Entry

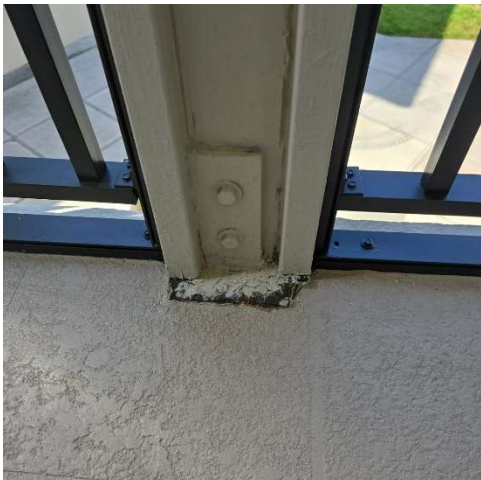
Some locations of corrosion at column bases/brackets observed. (see representative photos)

PHOTO-29 Typical Column Base Corrosion 2C

- As part of the concrete restoration punch-out, clean/remove any column base corrosion and apply a corrosion-inhibiting paint.

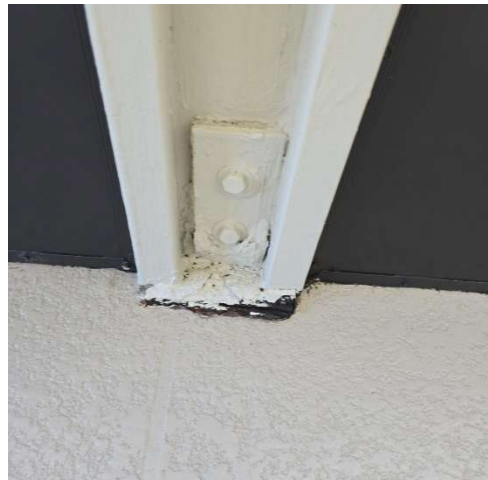
PHOTO-30 Typical Column Base Corrosion near 1B
