MILESTONE INSPECTION REPORT FORM PHASE 1

a. Name on Title: THE LONGWOOD CONDOMINIUM ASSOCIATION, INC.			
b. Street Address: 11811 Avenue of the PGA, Palm Beach Gardens, FL 33418

c. Legal Description: LONGWOOD NO 3 COND BLDG 5			
d. Owner's Name: THE LONGWOOD CONDOMINIUM ASSOCIATION, INC.			
e. Owner's Mailing Address: 11811 Avenue of the PGA, Palm Beach Gardens, FL 33418

LONGWOOD CONDO - BLDG 5 - REPRESENTATIVE PHOTOS

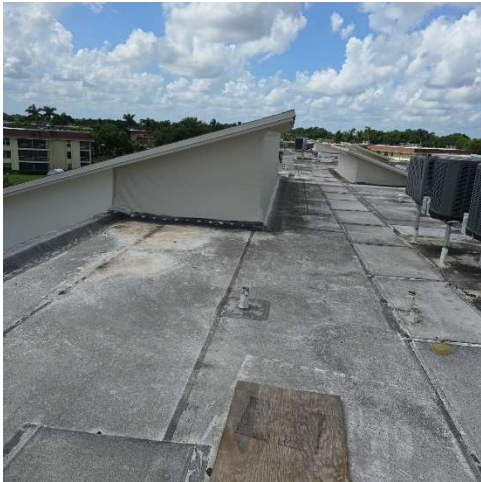
- Standing water or membrane staining.
- Poorly installed or sealed flashing details, especially along TPO to asphalt transitions.
- Roof drains missing dome covers.
- Old ceiling stain in unit 3F.

PHOTO-09 Typical Roof Staining

- Repair areas with truss and fascia rot.
- Clean and maintain the roof system, drains, scuppers, and downspouts per the manufacturer's warranty and as part of the routine maintenance program. Ensure all downspouts are equipped with splash blocks and drain away from the foundation to prevent erosion. Install any missing roof drain domes.

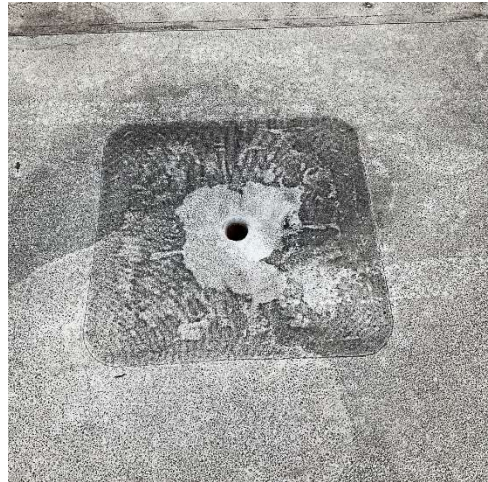
PHOTO-10 Typical Roof Drain Missing Domes

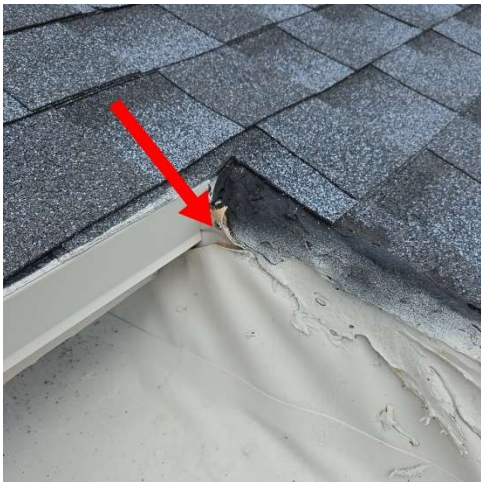
PHOTO-11 Poor Roof Flashing

- Quantify and repair areas of unsound, missing, or damaged stucco around the building exterior (typical e.g. Unit 3E balcony).
- Repair all poorly installed or sealed roof flashing.

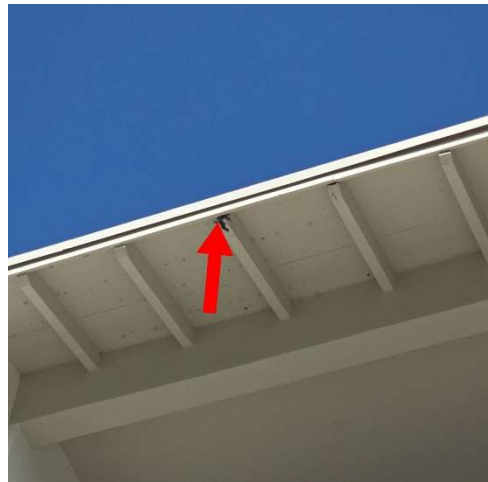
Isolated areas of wood truss end or fascia rot along overhangs.

PHOTO-12 Typical Truss Fascia Rot

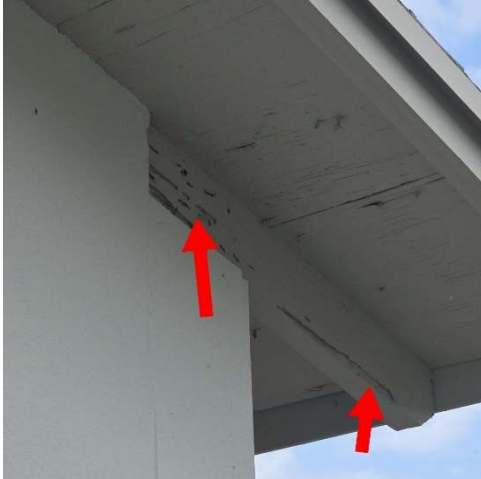
PHOTO-13 Typical Truss Fascia Rot

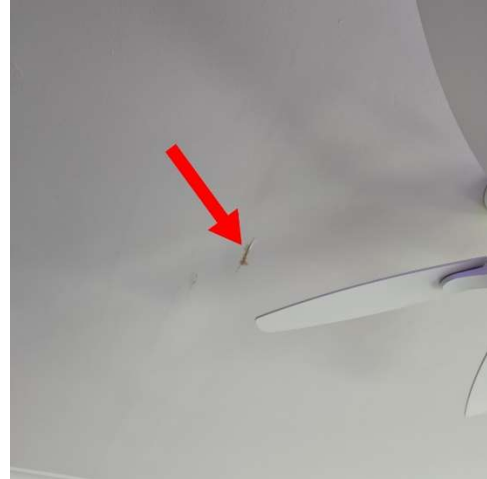
PHOTO-14 Old Ceiling Staining Unit 3F

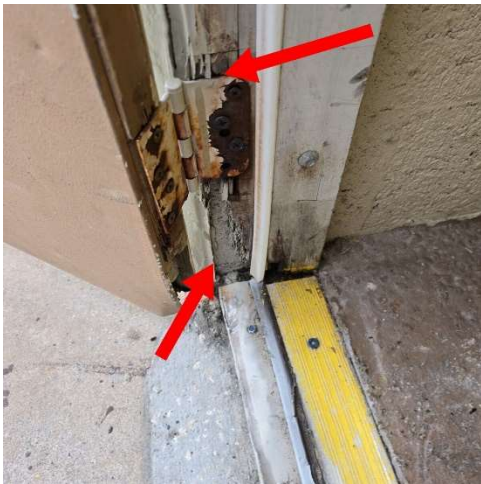
1. The assemblies are generally in good condition, consistent with the age of the building.
2. Some doors or frames exhibited signs of corrosion.

PHOTO-21 Typical Door Frame Rot Trash Room

Monitor and repair any areas of corrosion or replace the assemblies as needed as part of routine building maintenance.

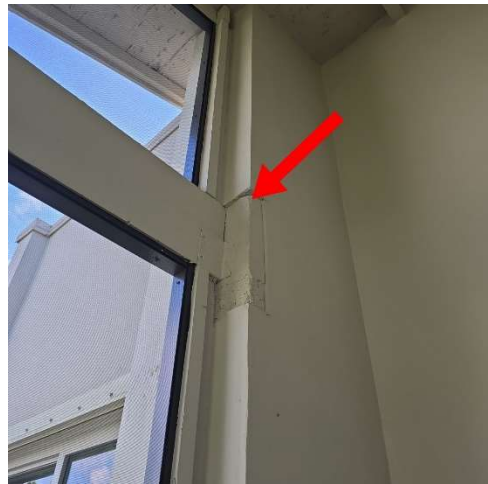
- Isolated locations of wood rot along the fascia or overhang truss ends.
- Corrosion noted at select column bases and brackets.
- Areas of cracked, damaged, missing, or unsound stucco finishes. (typical e.g. Unit 3E balcony.)
- Areas of damaged or deteriorated exterior sealants.

PHOTO-22 Missing Stucco Unit 3E

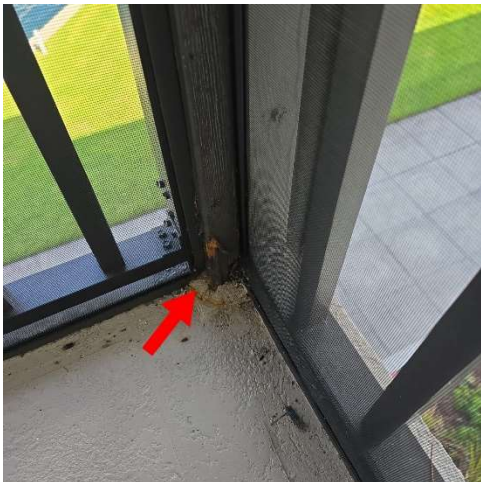
Some locations of corrosion at column bases/brackets observed. (see representative photos)

PHOTO-23 Typical Column Base Corrosion 3D

- As part of the concrete restoration punch-out, clean/remove any column base corrosion and apply a corrosion-inhibiting paint.

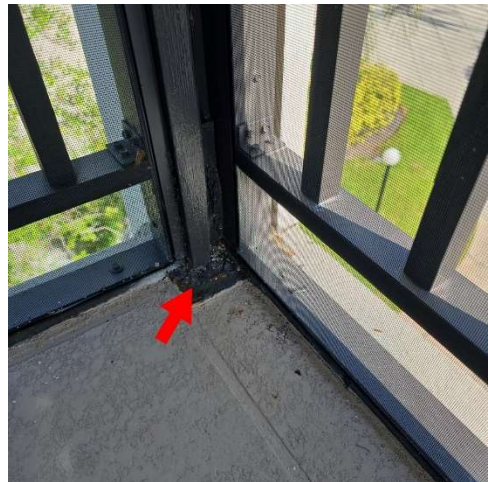
PHOTO-24 Typical Column Base Corrosion 3F
