# MILESTONE INSPECTION REPORT FORMS - STRUCTURAL BSIP INSPECTION FORM

## MILESTONE INSPECTION REPORT FORM PHASE 1

a. Name on Title: THE LONGWOOD CONDOMINIUM ASSOCIATION, INC.			
b. Street Address: 11811 Avenue of the PGA, Palm Beach Gardens, FL 33418

# LONGWOOD CONDO - BLDG 6 - REPRESENTATIVE PHOTOS

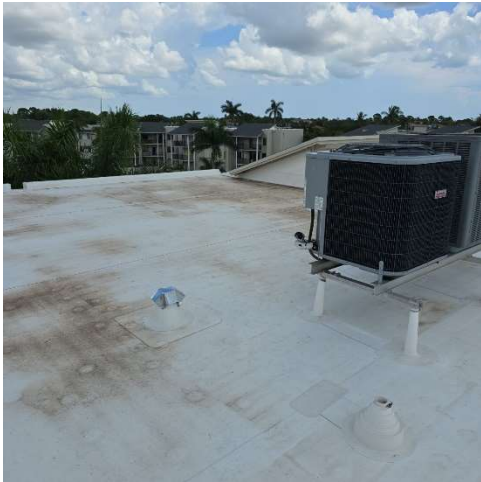
- Standing water or membrane staining.
- Some exposed nail heads along the asphalt shingle areas.
- Poorly installed or sealed flashing details, especially along TPO to asphalt transitions.

PHOTO-09 Typical Roof Staining

- Repair areas with truss and fascia rot.
- Clean and maintain the roof system, drains, scuppers, and downspouts per the manufacturer's warranty and as part of the routine maintenance program. Ensure all downspouts are equipped with splash blocks and drain away from the foundation to prevent erosion. Install any missing roof drain domes.

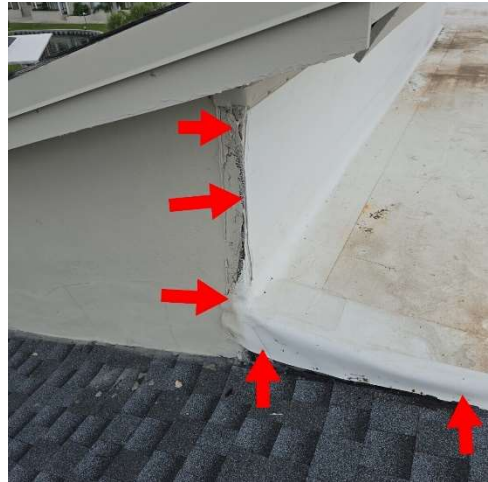
PHOTO-10 Poor Flashing and Exposed Nails

- Quantify and repair areas of unsound, cracked, or damaged stucco around the building exterior.
- Repair any exposed asphalt shingle nail heads and poorly installed or sealed roof flashing.

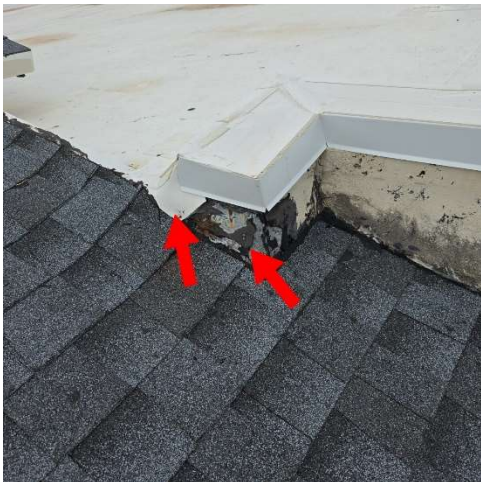
PHOTO-11 Poor Flashing and Exposed Nails

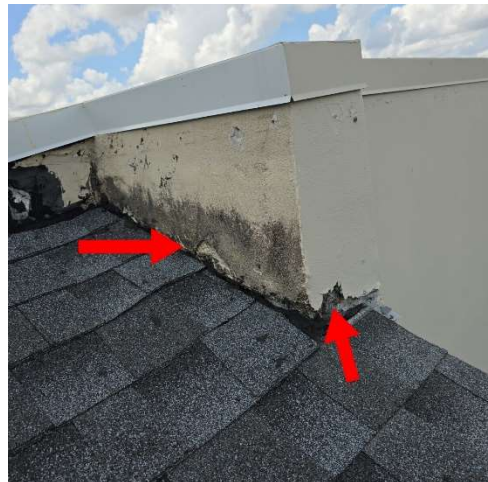
PHOTO-12 Poor Roof Flashing

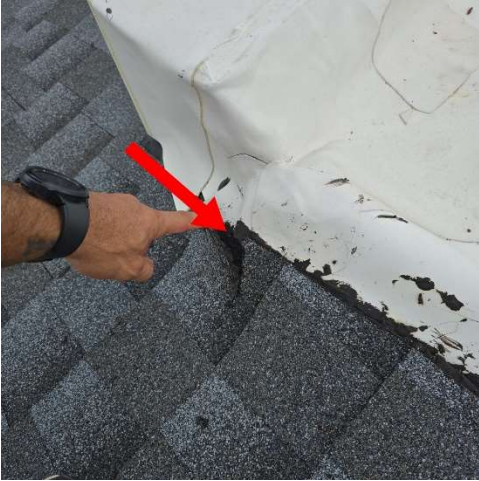
PHOTO-13 Poor Flashing and Damaged Shingle

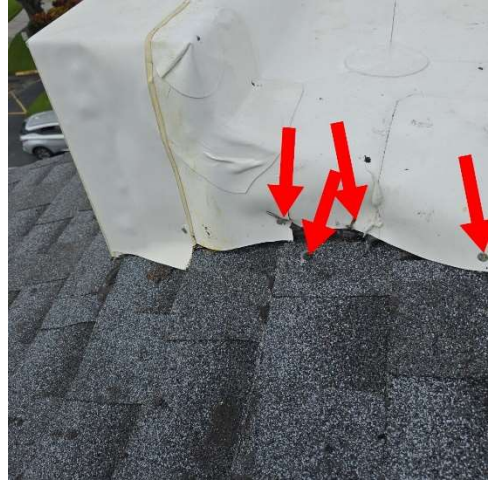
PHOTO-14 Exposed Roof Nails

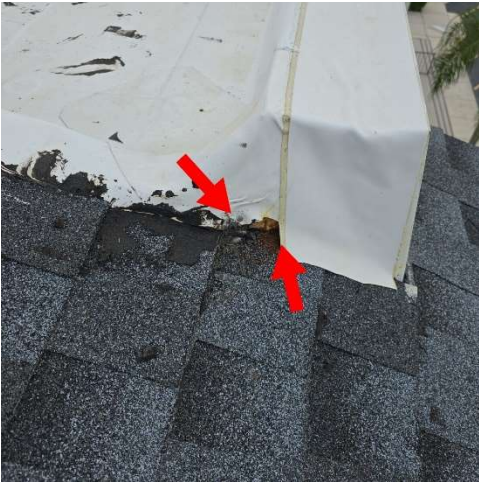
PHOTO-15 Poor Flashing and Exposed Nails

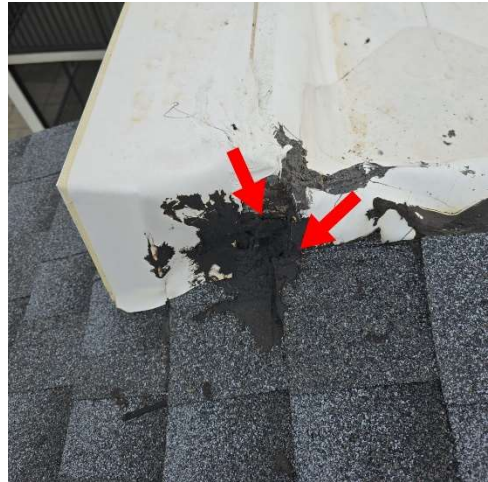
PHOTO-16 Poor Flashing Sealant

- Repair any damaged or deteriorated sealants per the manufacturer's installation instructions (i.e. surface prep, cure time, and application thickness). Repair any adjacent areas of wood rot, moisture intrusion, efflorescence, and corrosion as necessary.

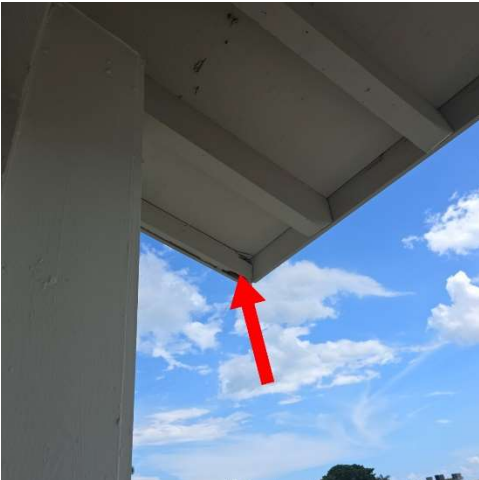
Isolated areas of wood truss end or fascia rot along overhangs.

PHOTO-17 Typical Truss Fascia Rot

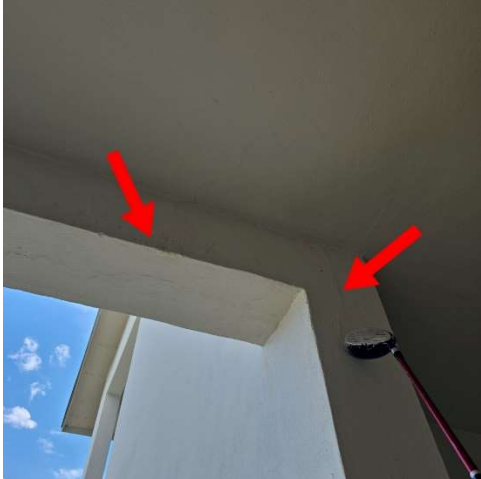
PHOTO-25 Typical Unsound Stucco and Efflorescence near 2D

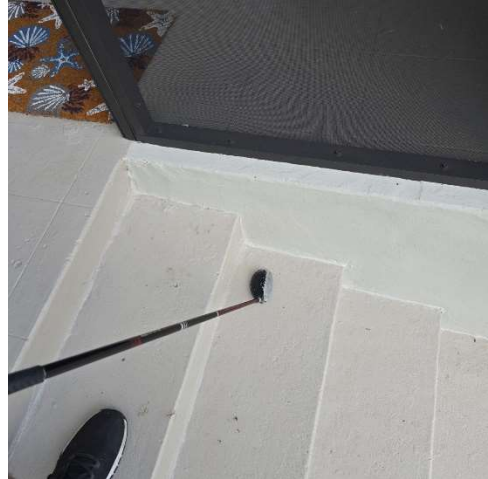
PHOTO-26 Typical Unsound Stucco near 1A

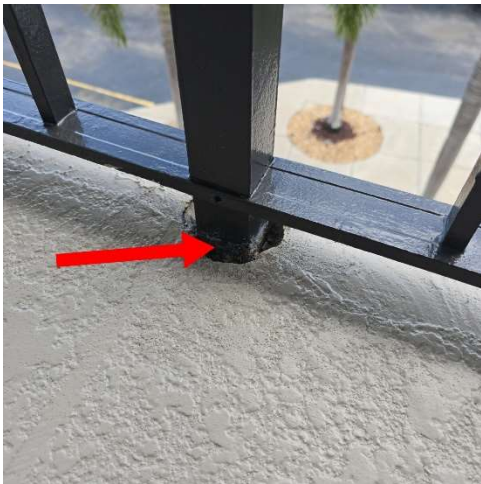
Missing railing post grout and a loose railing-to-wall connection noted along 3rd floor catwalk near unit 3B.

PHOTO-27 Railing Post Pocket Missing Grout near 3B

- Repair any loose railing connections and install post grout where missing (typical e.g. catwalk railing near unit 3B).

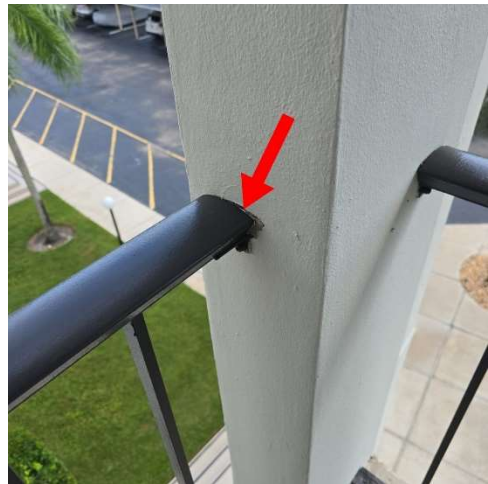
PHOTO-28 Loose Handrail to Wall Connection near 3B

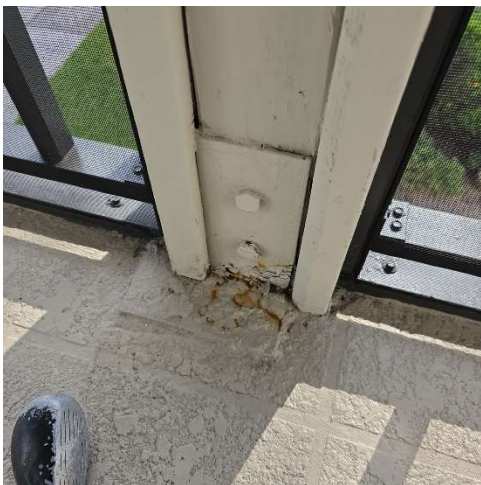
Some locations of corrosion at column bases/brackets observed. (see representative photos)

PHOTO-29 Typical Corroded Column 2F

- As part of the concrete restoration punch-out, clean/remove any column base corrosion and apply a corrosion-inhibiting paint.

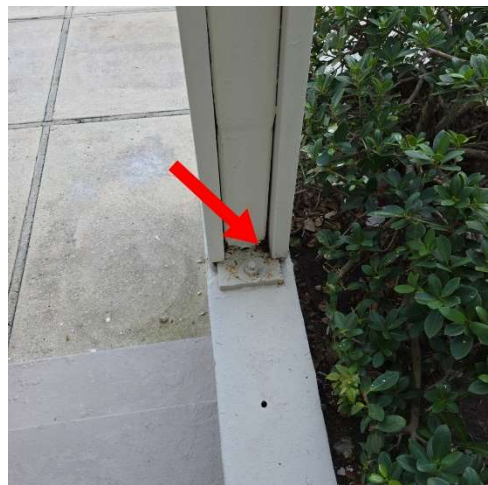
PHOTO-30 Typical Corroded Column Base near 1A
