MILESTONE INSPECTION REPORT FORMS - STRUCTURAL BSIP INSPECTION FORM

MILESTONE INSPECTION REPORT FORM PHASE 1

a. Name on Title: THE LONGWOOD CONDOMINIUM ASSOCIATION, INC.			
b. Street Address: 11811 Avenue of the PGA, Palm Beach Gardens, FL 33418

LONGWOOD CONDO - BLDG 7 - REPRESENTATIVE PHOTOS

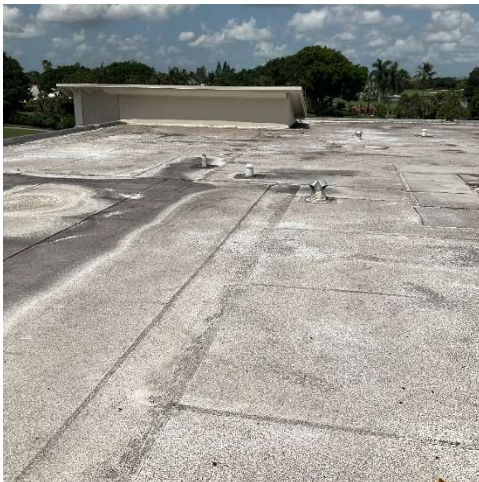
- Standing water or membrane staining.
- Roof drains missing dome covers with dirt and debris accumulation.
- Poorly installed or sealed flashing details, especially along TPO to asphalt transitions.

PHOTO-09 Typical Roof Staining

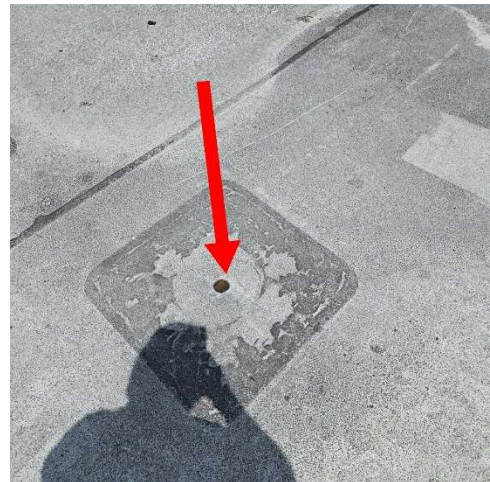
PHOTO-10 Typical Roof Drain Missing Dome

- Repair all poorly installed or sealed roof flashing.
- Repair areas with truss and fascia rot.
- Clean and maintain the roof system, drains, scuppers, and downspouts per the manufacturer's warranty and as part of the routine maintenance program. Ensure all downspouts are equipped with splash blocks and drain away from the foundation to prevent erosion. Install any missing roof drain domes.
- Repair any damaged or deteriorated sealants per the manufacturer's installation instructions (i.e. surface prep, cure time, and application thickness). Repair any adjacent areas of wood rot, moisture intrusion, efflorescence, and corrosion as necessary.
- As part of the concrete restoration punch-out, clean/remove any column base corrosion and apply a corrosion-inhibiting paint.

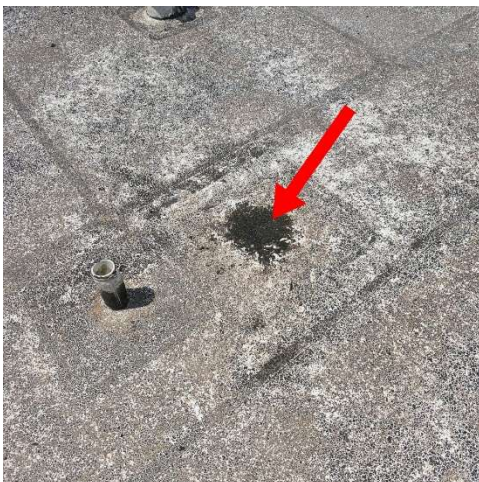
PHOTO-11 Debris at Roof Drain

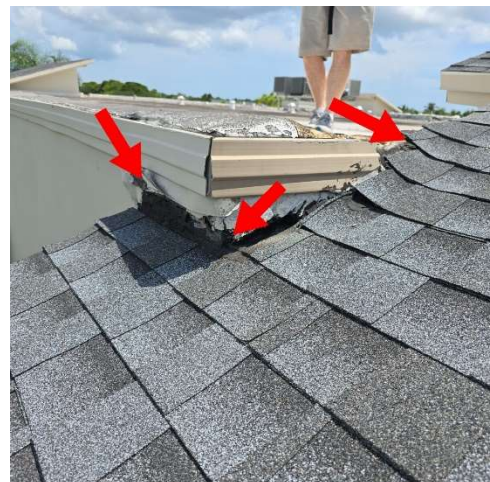
PHOTO-12 Poor Roof Flashing

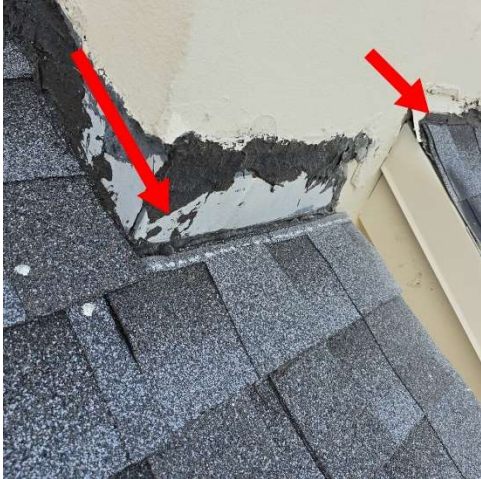
PHOTO-13 Poor Roof Flashing

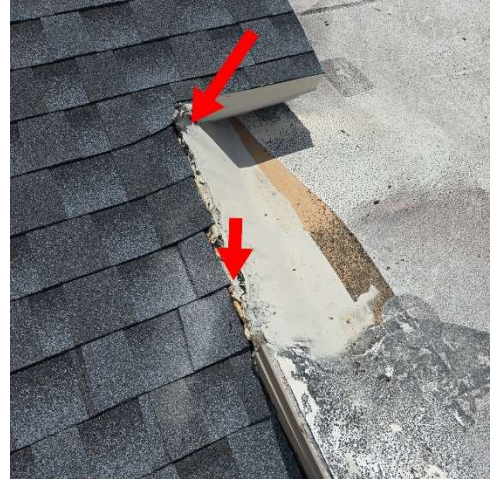
PHOTO-14 Poor Roof Flashing

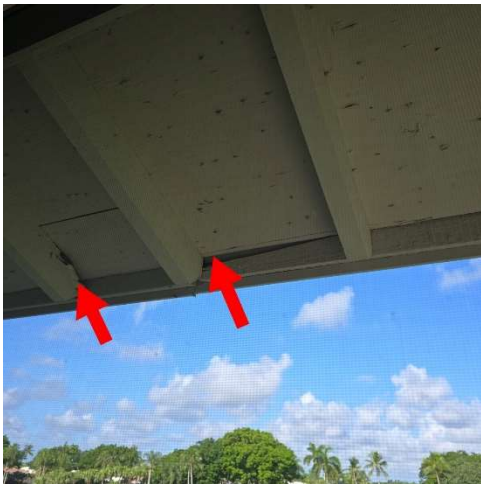
Isolated areas of wood truss end or fascia rot along overhangs.

PHOTO-15 Typical Truss Fascia Rot

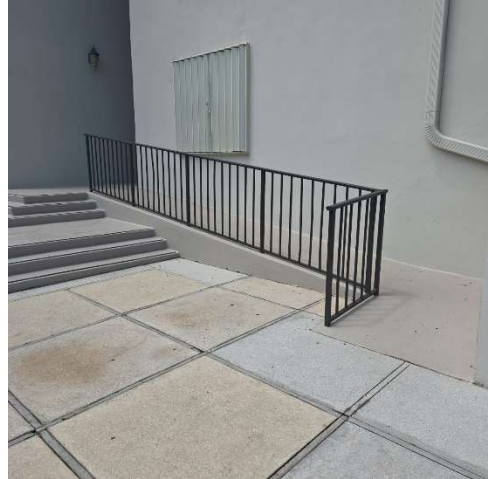
A low-slope concrete entrance ramp noted in generally good condition.

PHOTO-20 Entry Ramp

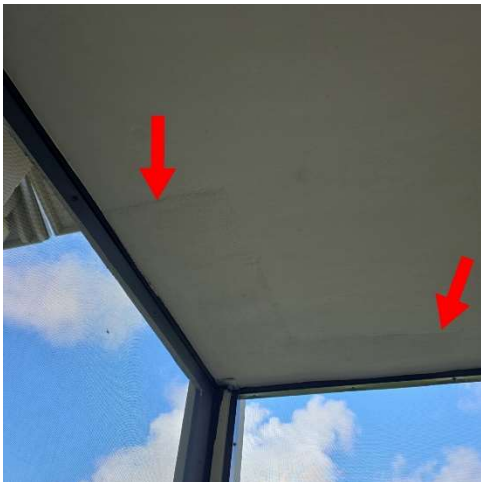
Per building records, the building recently performed a concrete restoration project circa 2024 (BCOM-23-08-00686)

PHOTO-23 Typical Previous Concrete Repair

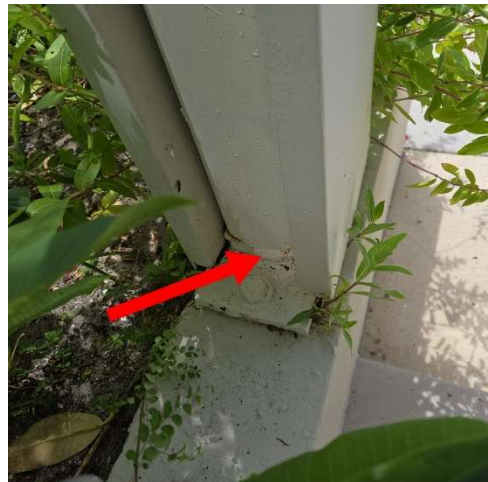
Some locations of corrosion at column bases/brackets observed. (see representative photos)

PHOTO-24 Typical Column Base Corrosion
